MEETING NOTES

Facilities Master Plan Update
College of the Redwoods, Redwoods CCD
7351 Tompkins Hill Road
Eureka, CA 95501

tBP Project No. 22085.00
SWOT Meeting with Facilities Planning Committee
Date: March 29, 2022

Facilities Master Plan Update
Facilities Planning Committee Meeting
Evaluation of Existing Conditions
March 29, 2022

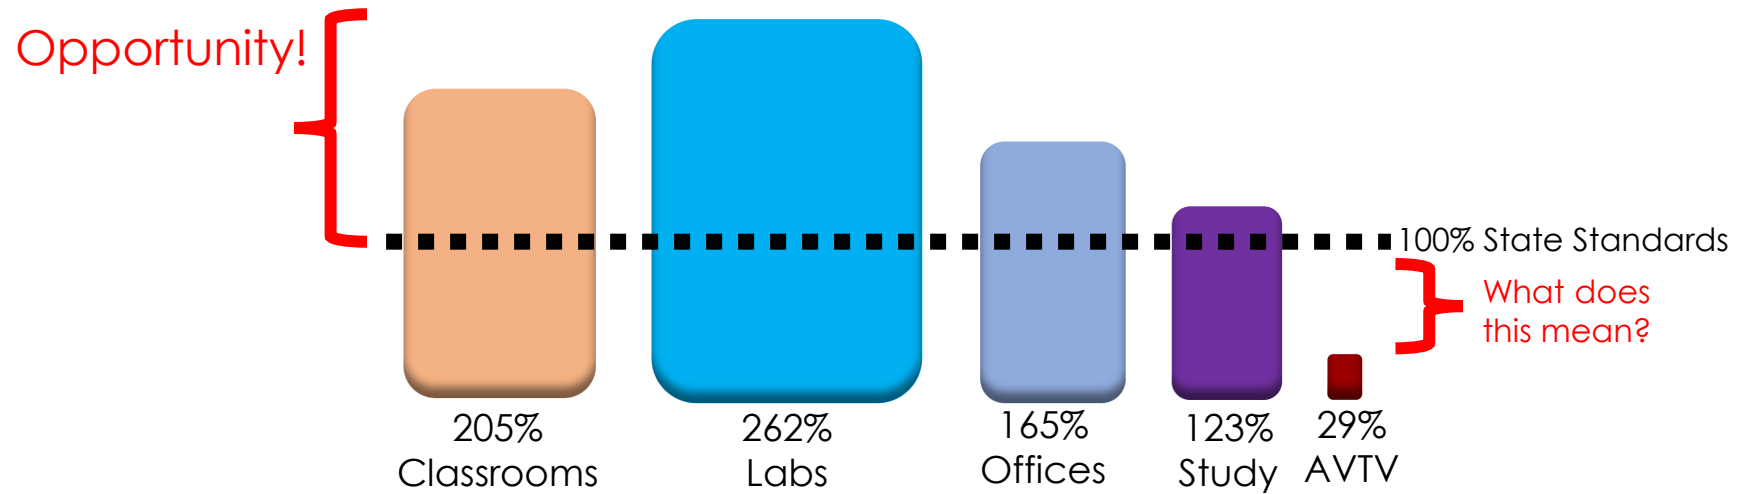
How Does the Eureka Campus Compare to the Space Standards?

The group viewed a chart showing the analysis of space at the Eureka campus based upon the base-line attendance during the 2017-2018 year.

- The Eureka campus has significantly more space than the State's space standards account for in classrooms and labs, and to a lesser extent in other categories.

- The campus has only 29% of the State standard space allocation for AVTV space. This is the category of specialized spaces for online content and distribution.

- Categories of excess space might improved or reorganized to improve more aligned space utilization to State standards.
- The analysis excludes vacated & replaced buildings including the Life Science and Physical Sciences buildings. It also includes the Academy of the Redwoods and college-occupied spaces in RBC-A and B.

- Excess existing space for learning
- Need more technology-rich AVTV spaces

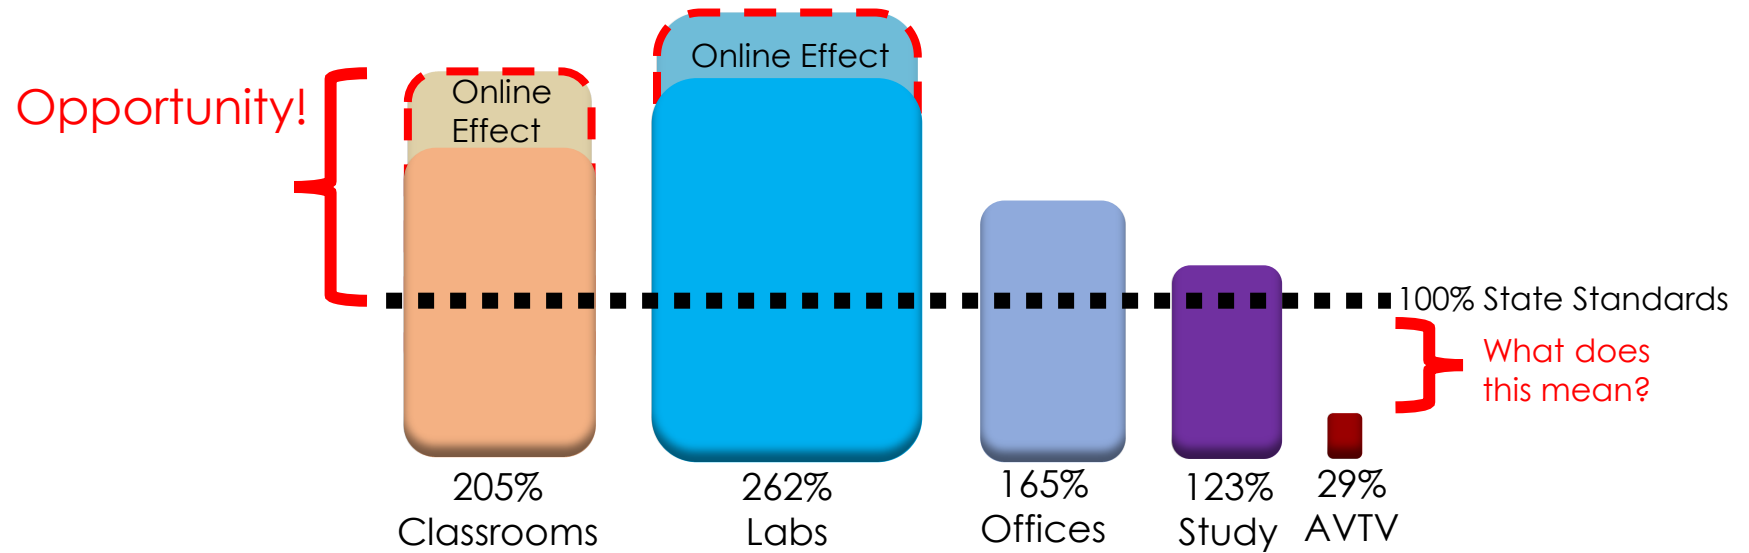
What is the effect of online instruction on your space?

The group reviewed the 'online effect' on the space analysis chart.

- In 2017-2018, 13% of District-wide FTES was collected online. This figure rose to 37% in 2020-2021, as the College's pandemic response caused most on-campus functions to shift online.

- The increasing use of online modes for instruction, support services and events, impact the use of physical space. For example, it frees up space in classrooms for other uses.

- The chart shows the impact of 13% online FTES. As online instruction increases, the online effect will increase. This means that more existing space will be available for other uses.

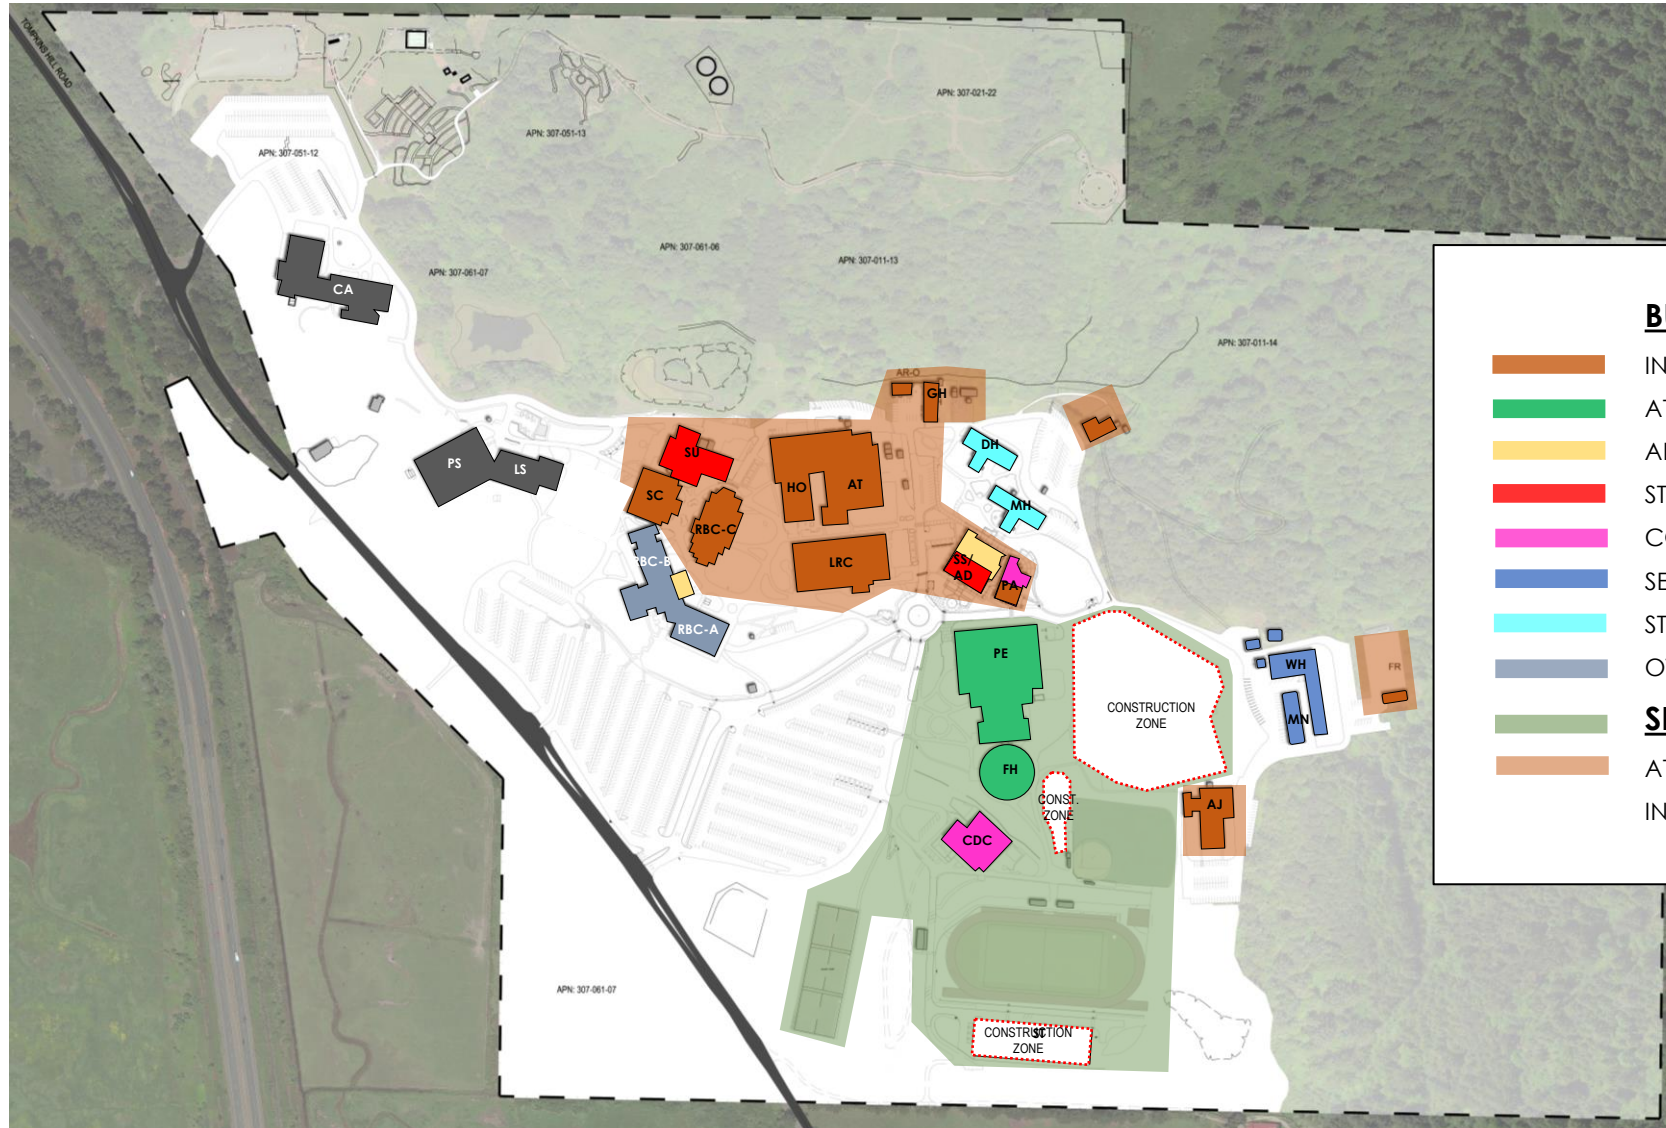
Eureka Campus: Existing Building/Site Zoning

The group reviewed a zoning diagram of the campus' organization.

- Campus development has shifted towards the east over the past 20 years. With the replacement of the Creative Arts Building, the instructional zone is extending to the east.
- The Student Union (Student Resource Center) is now located at the western edge of the campus once the buildings to the west have been demolished, which puts it at a distance from most of the campus.
- The most-used spaces for students to hang out is in the cafeteria in SRC and the Library.

Eureka Zoning and Circulation – As campus development continues to shift toward the east, conflicts between vehicular and pedestrian traffic will increase. There is a lack of indoor and outdoor spaces for hanging out, informal gathering and events. There is no ‘heart of campus activity’ that is supported by core campus functions.

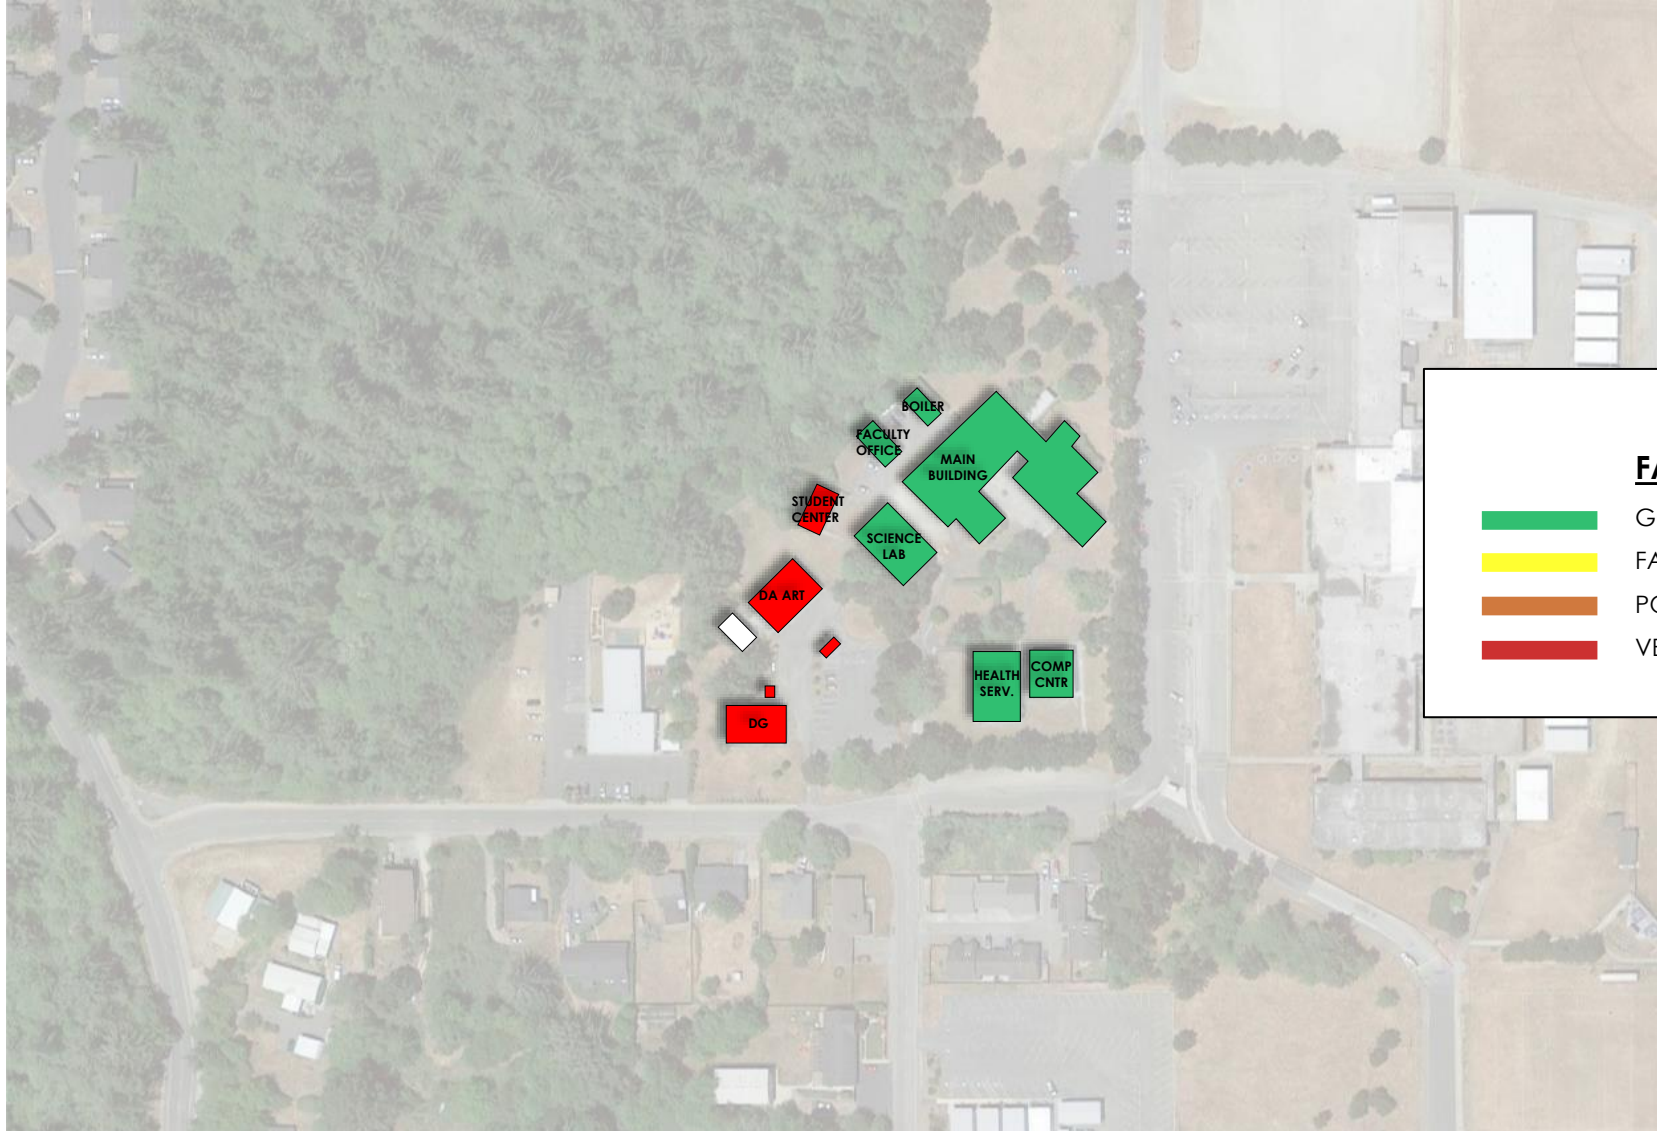
Del Norte Campus: Existing Facility Condition

The group reviewed analysis diagrams of the Del Norte Educational Center in Crescent City.

- The main building was modernized in 2005; the current rating is Good. The 2019 FMP includes a project to upgrade electrical systems, pull cables to enhance technology, and upgrade doors & windows to improve energy efficiency.
- The Science Building will be added to the diagram. Constructed in 2016, the current rating is Good.
- The Student Center, Art Building and Garage are in Very Poor condition.
- The group did not identify circulation or parking issues. The site is located adjacent to available parking at Del Norte High School.

Del Norte Facilities Conditions, Zoning and Circulation – There is a potential need to upgrade building systems for sustainable resource efficiency, improve technology.
